## **THE IMPACT OF LOW EFFICIENT EVACUATION PLAN DURING COSTA CONCORDIA ACCIDENT**

**MOHAMED NABIL ELNABAWYBAHRIZ & MOHAMED HUSSEIN NASSAR HASSAN**

Arab Academy for Science, Technology & Maritime Transport, Egypt

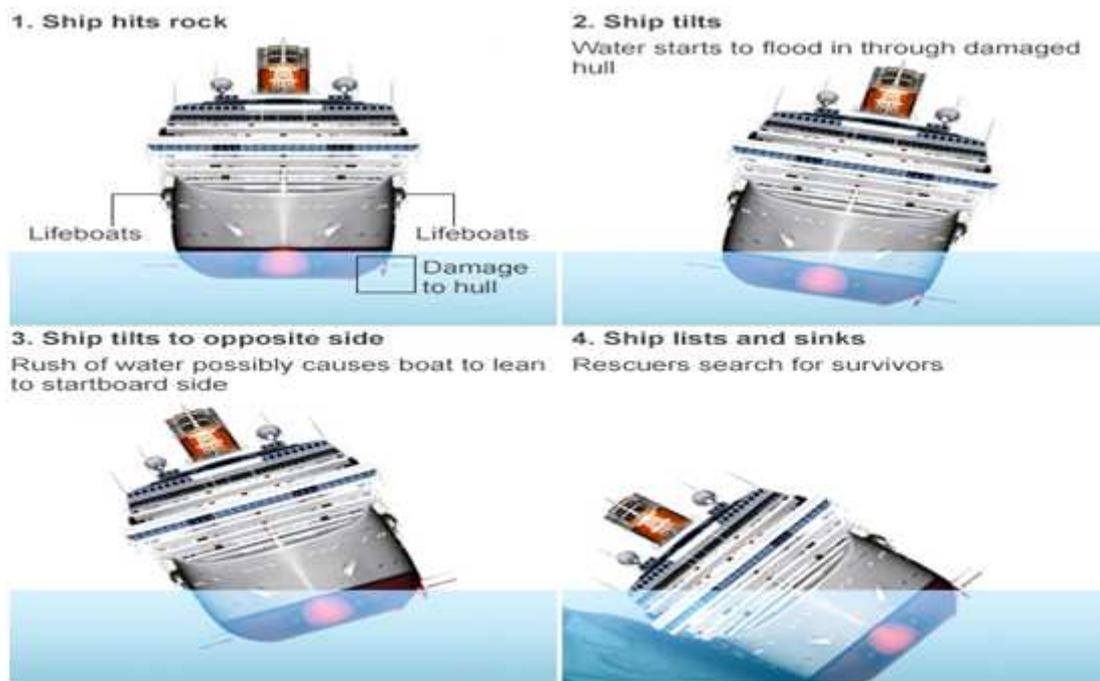
Figure 1

From the analysis carried out under the direct coordination of the Master, the seriousness of the scenario was reported after 16 minutes. After about 40 minutes (22: 27) the water reached the bulkhead deck in the aft area. (MIT, 2012)

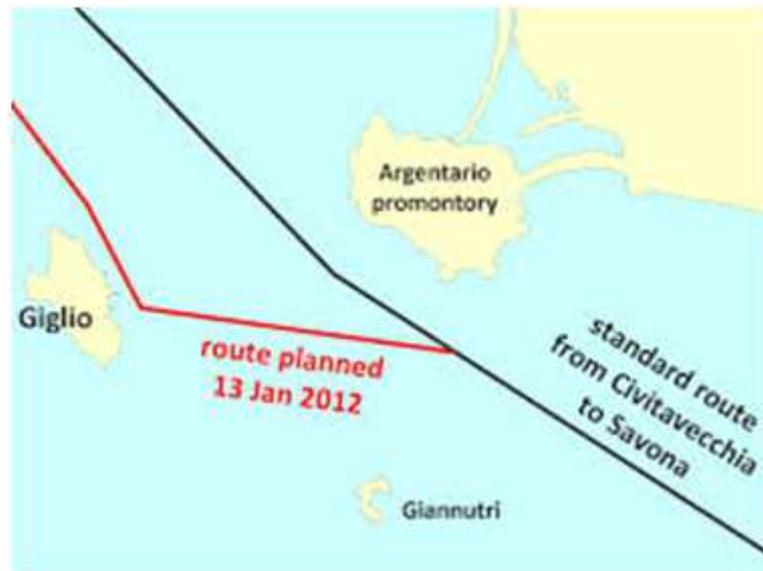
Figure 2

Having been damaged in compartments vital for power generation, power distribution and propulsion, the ship was soon adrift without electricity. Even though the emergency diesel generator started up, it did not work reliable enough to provide power. Therefore, emergency power was supplied by UPS (Uninterruptible Power Supply) batteries. However, the steering gear did not function and thrusters needed more than the emergency power provided. Due to wind and current, the vessel was ultimately moved north of Giglio harbor before the forces of nature turned her around 180 degrees and pushed her in the direction of the island until she grounded a second time. (OMAE, 2014)

At this time, the evacuation procedures were started, while the heeling angle to starboard unceasingly increased. In the early hours of the next morning, she had finally capsized and sunk onto the seabed approximately 25 meters deep until she was at last raised on September 16, 2013. (OMAE, 2014)
