# A comparative study for shear strengthening techniques of reinforced concrete beams using FRP

A. M. Morsy, N. H. El-Ashkar & K. M. Helmi

**ABSTRACT:** This paper presents the results of a pilot testing program that was undertaken to study the feasibility of strengthening RC beams in shear using FRP reinforcement internally embedded in holes drilled through the depth of the beam. Five similar beams were tested in this program, a control beam without strengthening, and three beams strengthened using externally bonded CFRP sheets, NSM CFRP strips and embedded CFRP and GFRP rods. The specimens strengthened with externally bonded sheets and internally embedded CFRP reinforcement had a 30% increase in their shear capacity while the specimens strengthened with NSM strips and internally embedded GFRP reinforcement had a 60% increase in their shear capacity, compared to the control specimens. The results thus confirm the feasibility of the proposed technique.

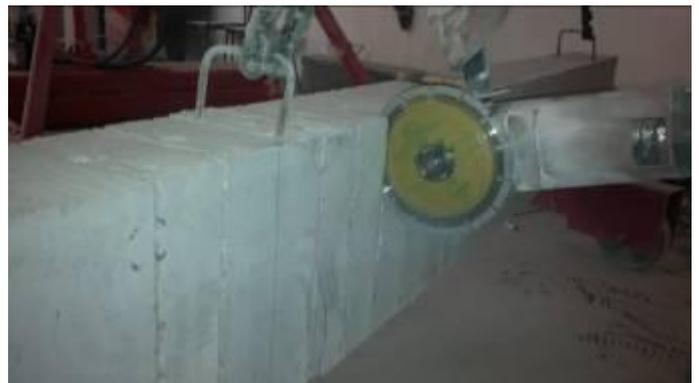
Figure 3 Cutting grooves for specimen NSM

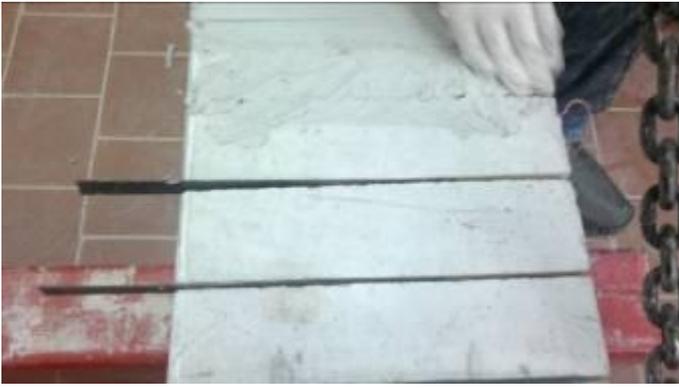
Figure 4 Installing FRP strips in specimen NSM

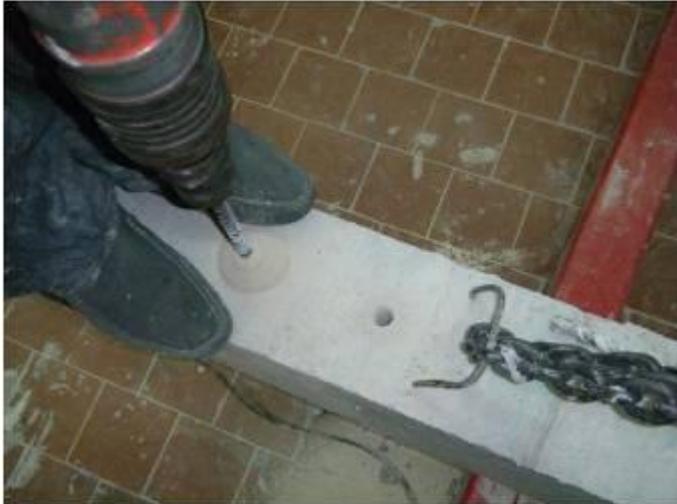
Figure 5 Drilling of holes for specimen IER-G

Figures 5 to 7 show the preparation work for specimen IER-G. The configuration of the specimens was chosen so all specimens would have an equal amount of material. Table 1 provides a summary of the details of the specimens used in this program.

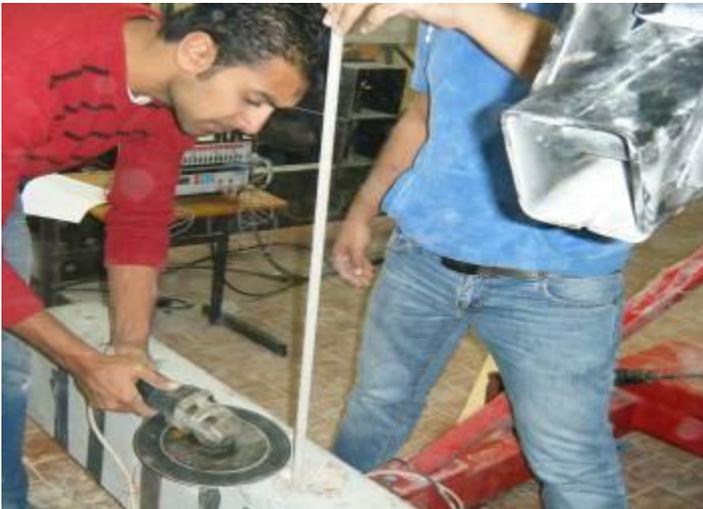
Figure 6 Installing of reinforcement in specimen IER-G

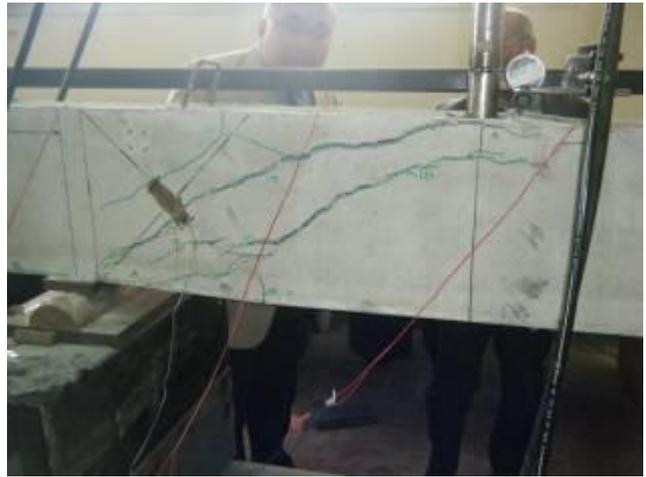
Figure 10 Crack pattern of control specimen

For the control specimen the first visible crack appeared at a load of about 70 kN. The crack extended from the point of loading to the support in the weak side. As loading progressed, the crack widened, and another major crack appeared in addition to several minor ones as seen in Figure 10. The specimen failed at a load of 100 kN. Although the failure was brittle it was less sudden than in the case of the other specimens

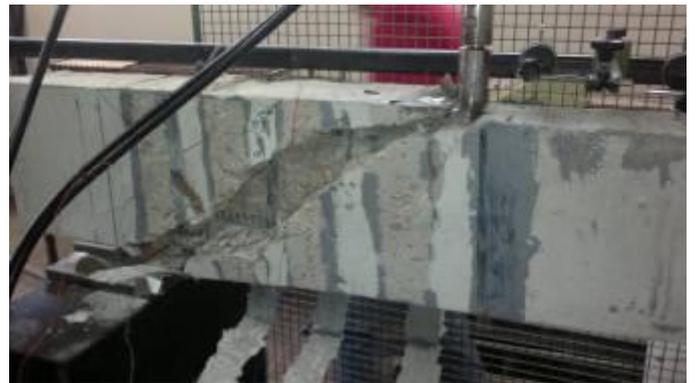
Post failure examination of the specimen showed a similar crack pattern to the control specimen as seen in Figure 11. It was noticed that the bonding failure took place in the concrete thin layer adjacent to the sheet, not in the adhesive epoxy.

Figure 11 Failure and crack pattern of specimen EB

The first visible crack appeared at a load of 78 kN between the sheets. As loading progressed, cracks widened then the specimen finally failed in a brittle manner at a load of 130 kN after debonding started at the second sheet after the support. Then with further loading the failure occurred progressively one sheet at a time.

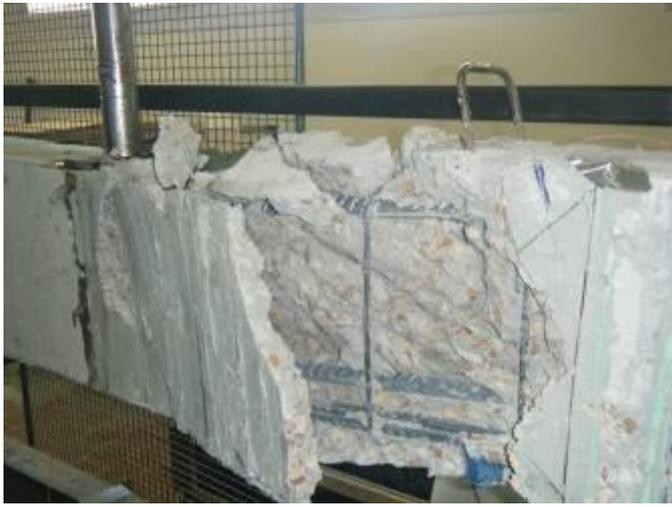
The first visible crack appeared at a load of 80 kN. Discontinued small cracks appeared between the strips as the loading progressed. The specimen failed suddenly in an explosive manner at a load of 155 kN, as the concrete cover containing the strips debonded from the beam's inner core as seen in Figure 12. After removing the concrete cover a similar crack pattern to the control specimen could be seen in the concrete core as seen in Figure 13. It was noticed that no de-bonding occurred between the CFRP laminates and the concrete.

Figure 12 Failure of specimen NSM

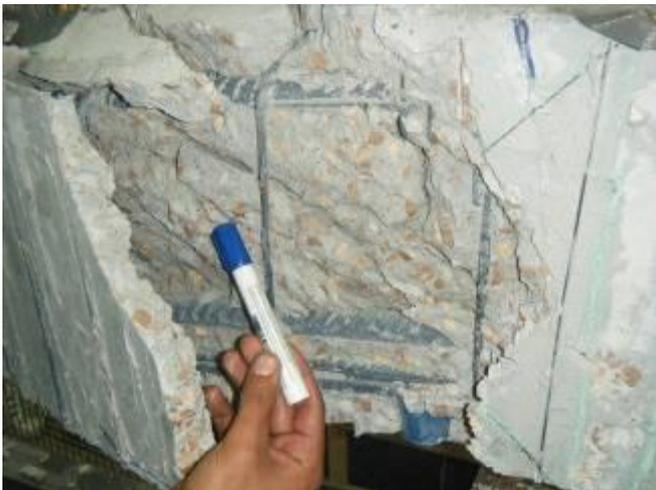
Figure 13 crack pattern of specimen NSM

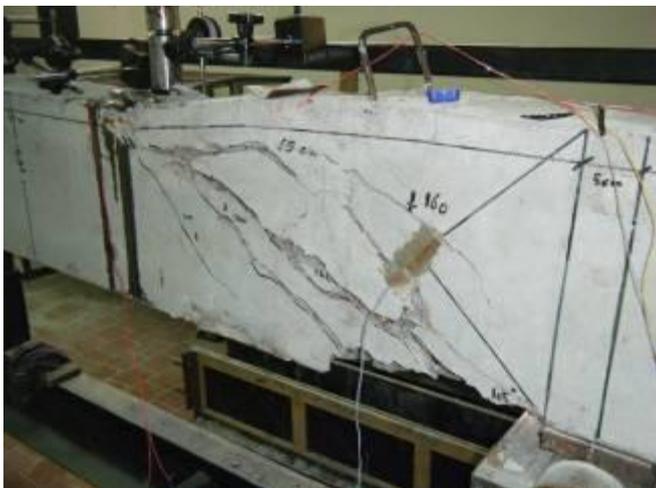
Several other cracks appeared and widened as the loading progressed, although at steeper angle as seen in Figure 14. Failure occurred suddenly at a load of 160 kN due to the de-bonding at the thin layer of concrete adhered to the GFRP bars. No de-bonding between the GFRP bars and the epoxy adhesive was observed and a thin concrete layer was noticed to be fully attached to the GFRP bar as seen in Figure 15.

Figure 14 Crack pattern of specimen IER-G

The first visible crack appeared at a load of 70 kN at the loading point at a steeper angle than in the case of the control specimen. This can be related to the crack arresting action of the embedded bars which altered the cracking pattern compared to the control specimen.

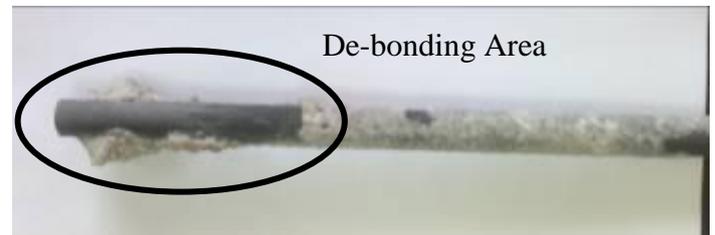
Specimen IER-C behaved in a similar manner to specimen IER-G where the cracks occurred in a steeper form than the control specimen. However, the specimen failed suddenly in a brittle manner at a load of 138 kN. It can be seen that this specimen failed 14 % lower than IER-G. After removing the concrete cover, it was noticed that the beam failed due to the de-bonding action of CFRP bars. On the contrary from the IER-G specimen the de-bonding took place between the bar's coating and its inner fiber core not in the thin concrete layer adjacent to the CFRP bar. This can be related to a manufacturing weak bond between the fiber core and its friction cover as seen in Figure 16.

Figure 16 CFRP bar after failure of specimen IER-C

NSM technique versus drilling one hole at the center of the beam every 150 mm in the IER technique. Although the use of CFRP reinforcement for IER strengthening yielded a smaller increase in the shear capacity this was due to the de-bonding between the coating and the internal fiber core of the bar. Therefore by enhancing the manufacturing technique for the CFRP and increasing the bond strength between the fiber core and the friction coating, the IER-C technique will yield at least the same shear strengthening capacity as the IER-G technique. This means also that a different surface treatment for the CFRP bar may produce better strengthening capacity. It is worth noting that the use of GFRP bars for this technique, which are more economical, yielded slightly better results than the NSM technique and had a 50% more strength enhancement over the EB technique.
